CERTIFICATE OF LOCATION OF GOVERNMENT CORNER

E1/4 Corner of Section 26, Township 101N, Range 16W, 5TH P.M.

STATE OF MINNESOTA, County of MOWER

E 1/4 cor Sec 26-101-16

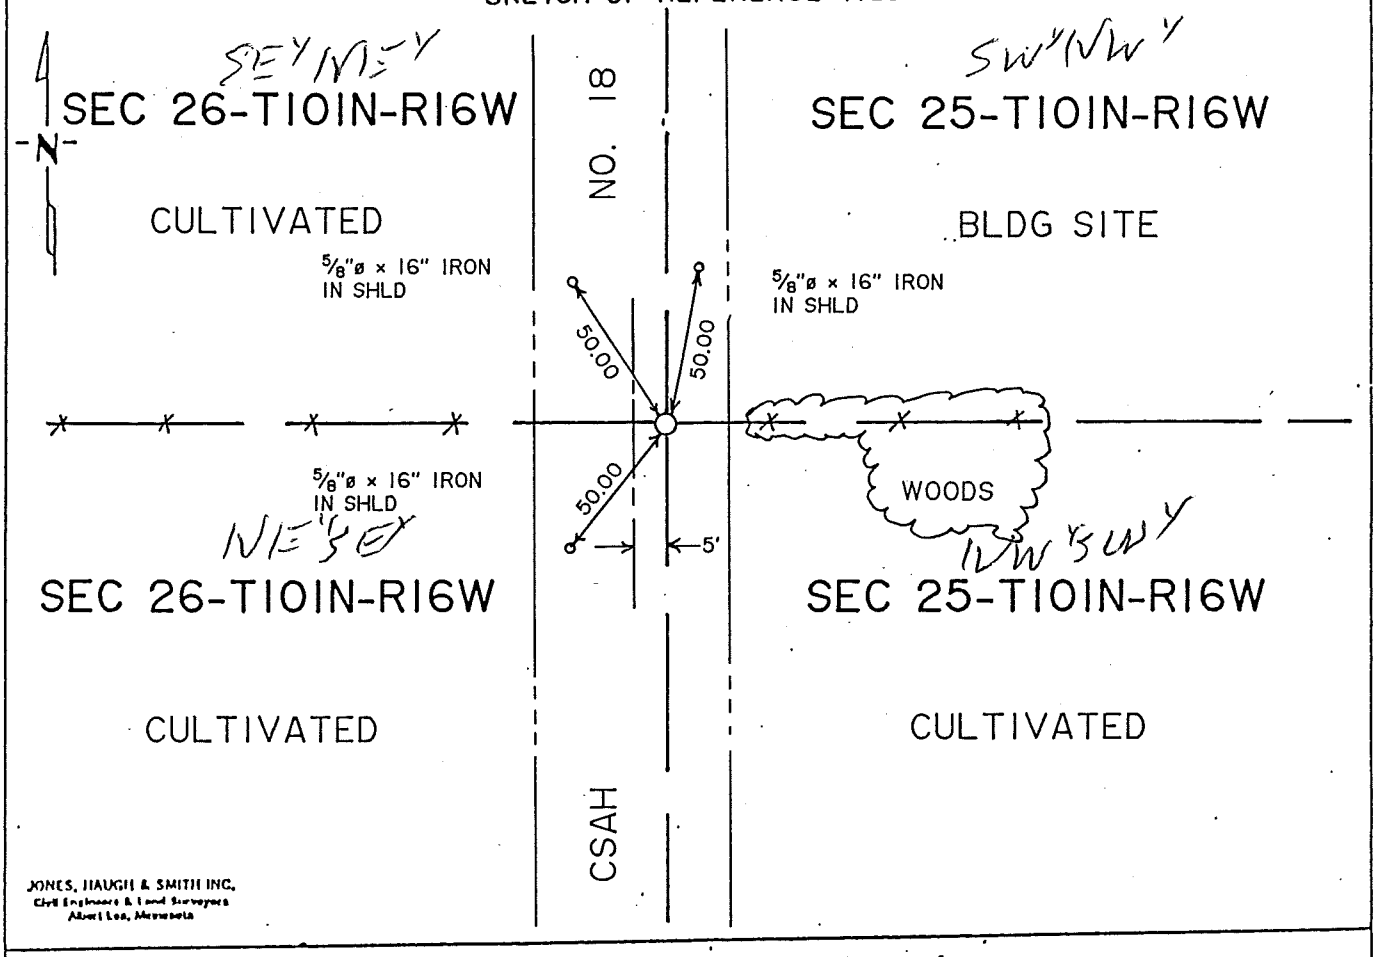
SKETCH OF REFERENCE TIES

☐ On 6-3-93 (DATE) found a STRAND OF BARBED WIRE AND A NEST OF LARGE STONES

1993 Jones, Haugh & Smith Inc crew under the direction of John H. Schulte IV, RLS 13807, dug a 4'x3'x10' hole five feet east of the centerline County State Aid Highway No. 18 and also in line with the east-west line fences. We dug to a depth of three feet which was into virgin soil and found a strand of barbed wire with a loop at end which ran west to line fence running west. Also there was a nest of large stones around and under barbed wire. County Road Plans show that section line would run five feet east of centerline of road. Therefore we accepted barbed wire and stones found as the perpetuation of the original public land survey and set a 5/8" diameter x 16" iron in center of stones and barbed wire and set a cast iron monument near road surface above barbed wire and stones.

The monument found and cast iron monument set fits occupation lines within the section and is accepted as best evidence of a perpetuation of the original public land survey corner.

☐ On 6-3-93 (DATE) placed a 5/8"ø x 16" IRON CAPPED RLS NO. 13807 IN CNT OF STONES AND A CAST IRON MONUMENT ABOVE STONES
