CERTIFICATE OF LOCATION OF GOVERNMENT CORNER

S1/4 Corner of Section 28, Township 101N, Range 16W, 5TH P.M.

STATE OF MINNESOTA, County of MOWER

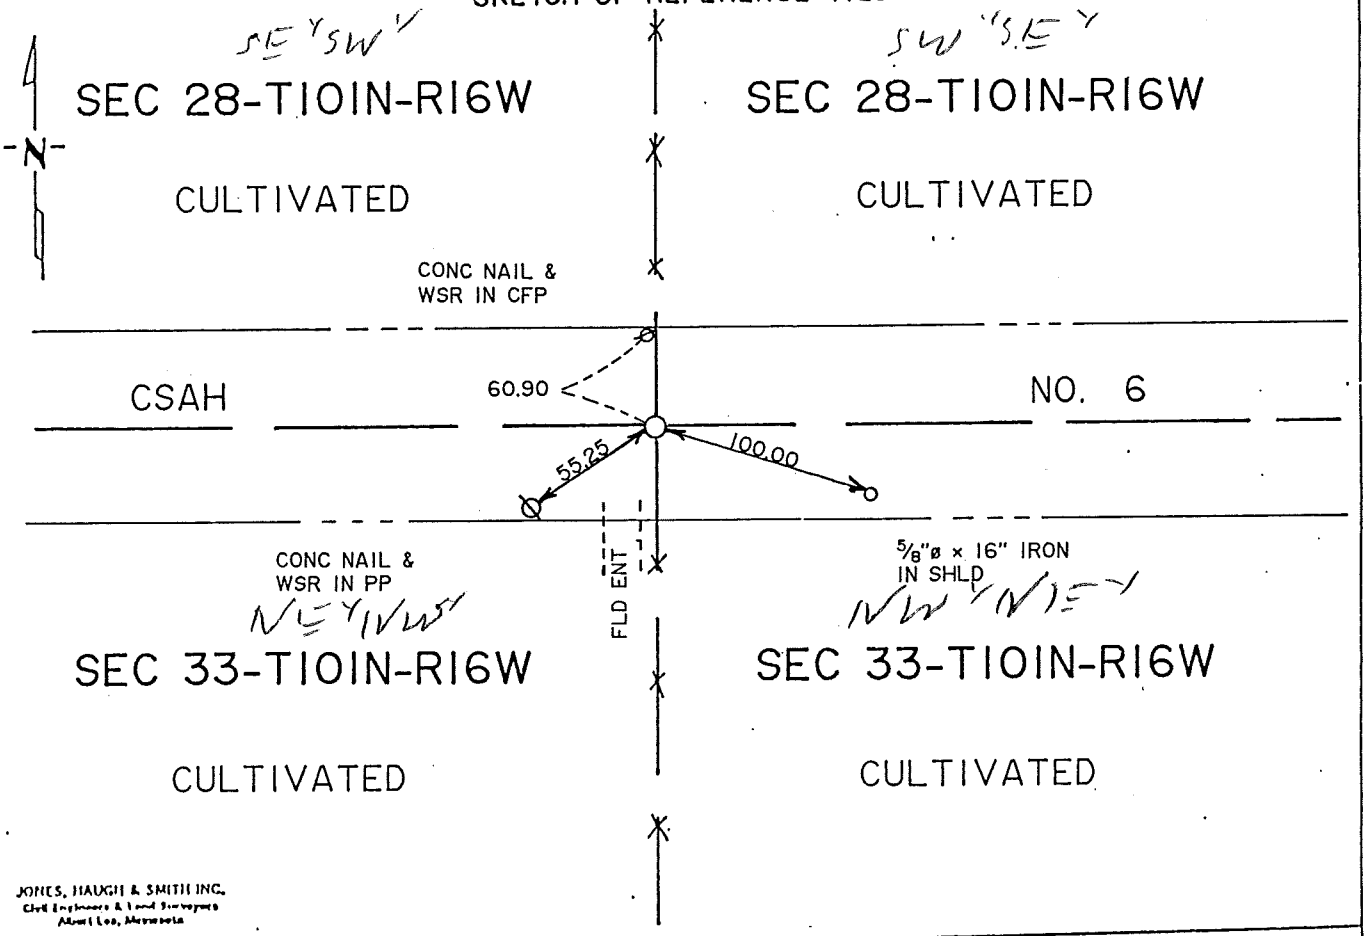
SKETCH OF REFERENCE TIES

At the corner location shown on the sketch:

☐ On 6-4-93 (DATE) found a MAGNETIC DISC AND A 6"ø CLAY TILE FILLED WITH CONC, AND A 3/8"ø IRON IN CNT

☐ On 6-4-93 (DATE) placed a CAST IRON MONUMENT

1993 Jones, Haugh & Smith Inc crew under the direction of John H. Schulte IV, RLS 13807, dug a 3'x2'x8' hole on the centerline of County State Aid Highway No. 6 and in line with north-south line fences. We found a magnetic disc 6" below road surface and a 6" diameter clay tile filled with concrete and a 3/8" diameter iron in center two feet below road surface. Therefore we accepted clay-concrete monument as the perpetuation of the public land survey corner and left in location found and set a cast iron monument near road surface above clay-concrete monument found.

The monument found and cast iron monument set fits occupation lines within the section and is accepted as best evidence of a perpetuation of the original public land survey corner.
