CERTIFICATE OF LOCATION OF GOVERNMENT CORNER

E 1/4 Corner of Section 5, Township 102N Range 17W, 5th P.M.

EAST QUARTER Corner of Section 5, Township 102N, Range 17W, 5 P.M.

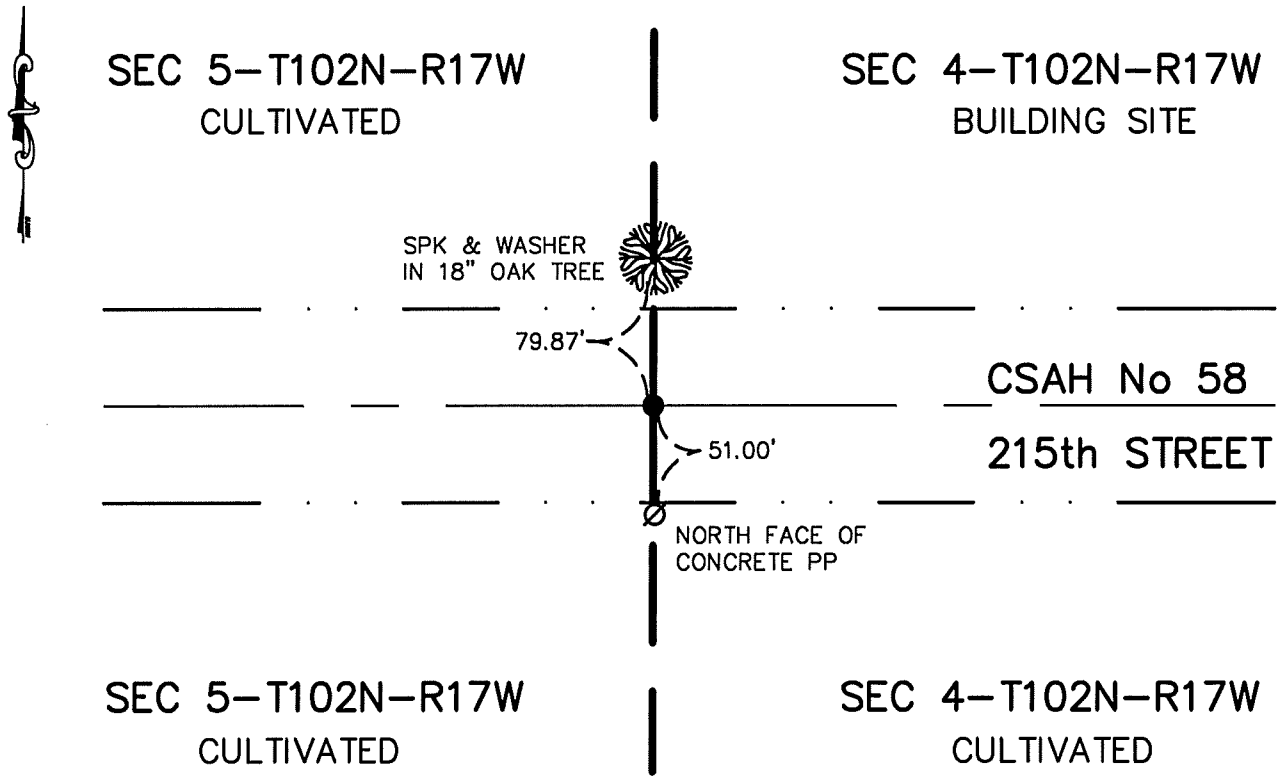
SKETCH OF REFERENCE TIES

☐ On 04/25/2000 (DATE) found a MOWER CO. HWY. DEPT. ALUMINUM MONUMENT

☒ left monument as found, ☐ lowered monument, ☐ removed monument (explain)

The monument fits occupation and road centerlines within the section and is accepted as best evidence of a perpetuation of the original public land survey corner.

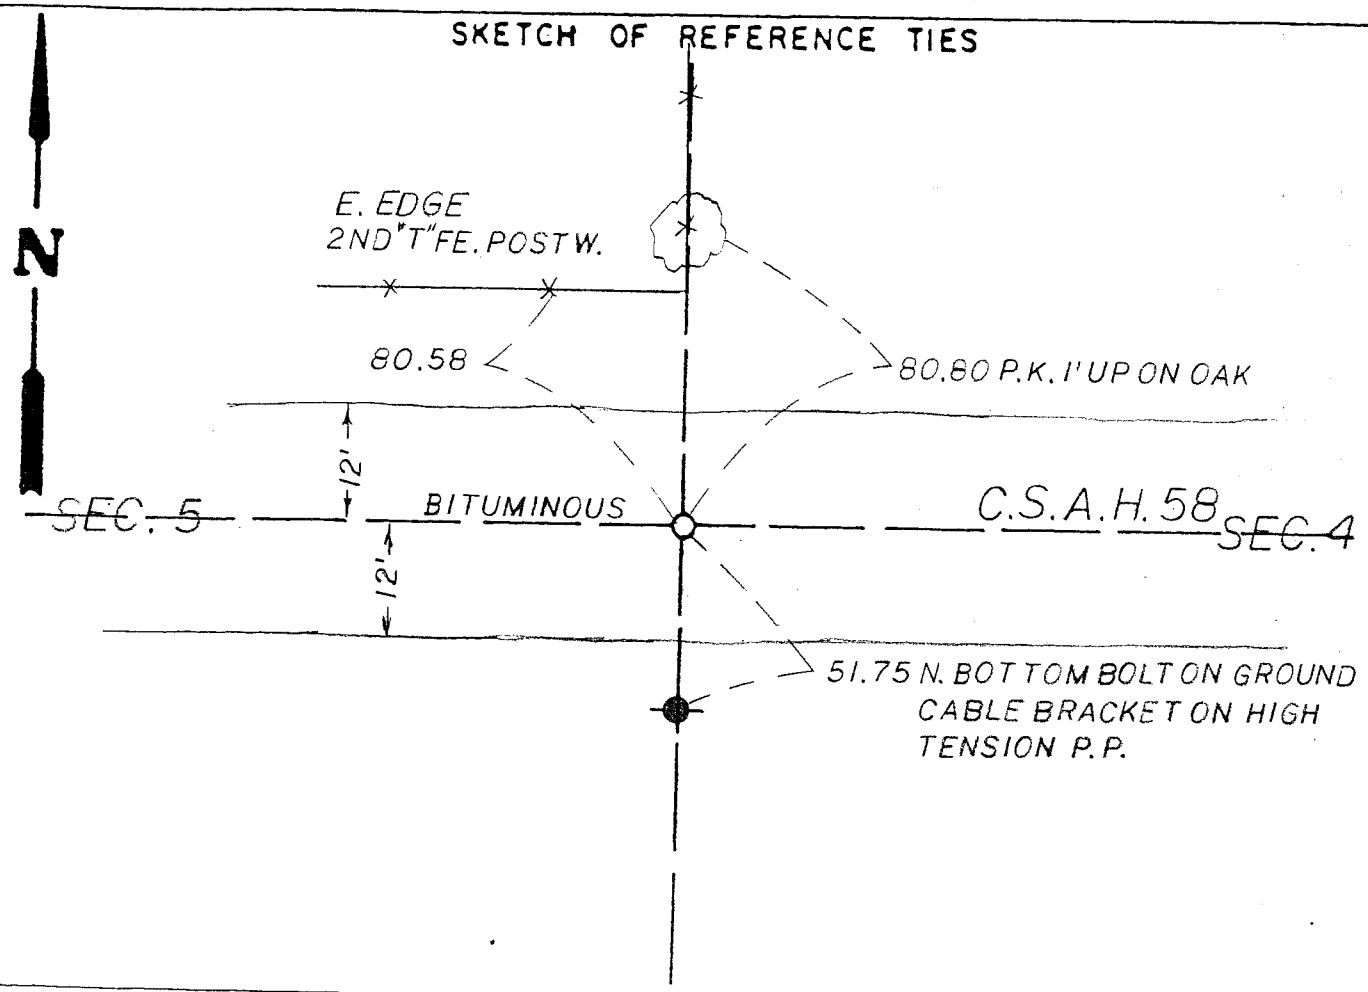
SKETCH OF REFERENCE TIES

On 9-4-90 found 1" BAR (REMOVED DURING EXCAVATION)

☐ left monument as found, ☐ lowered monument, ☒ removed monument (explain)

On 9-4-90 placed 5/8" BAR AND COUNTY CAP
