CERTIFICATE OF LOCATION OF GOVERNMENT CORNER

W1/4 Corner of Section 8, Township 102N Range 18W, 5th P.M.

W1/4 Corner Section 8-T102N-R18W

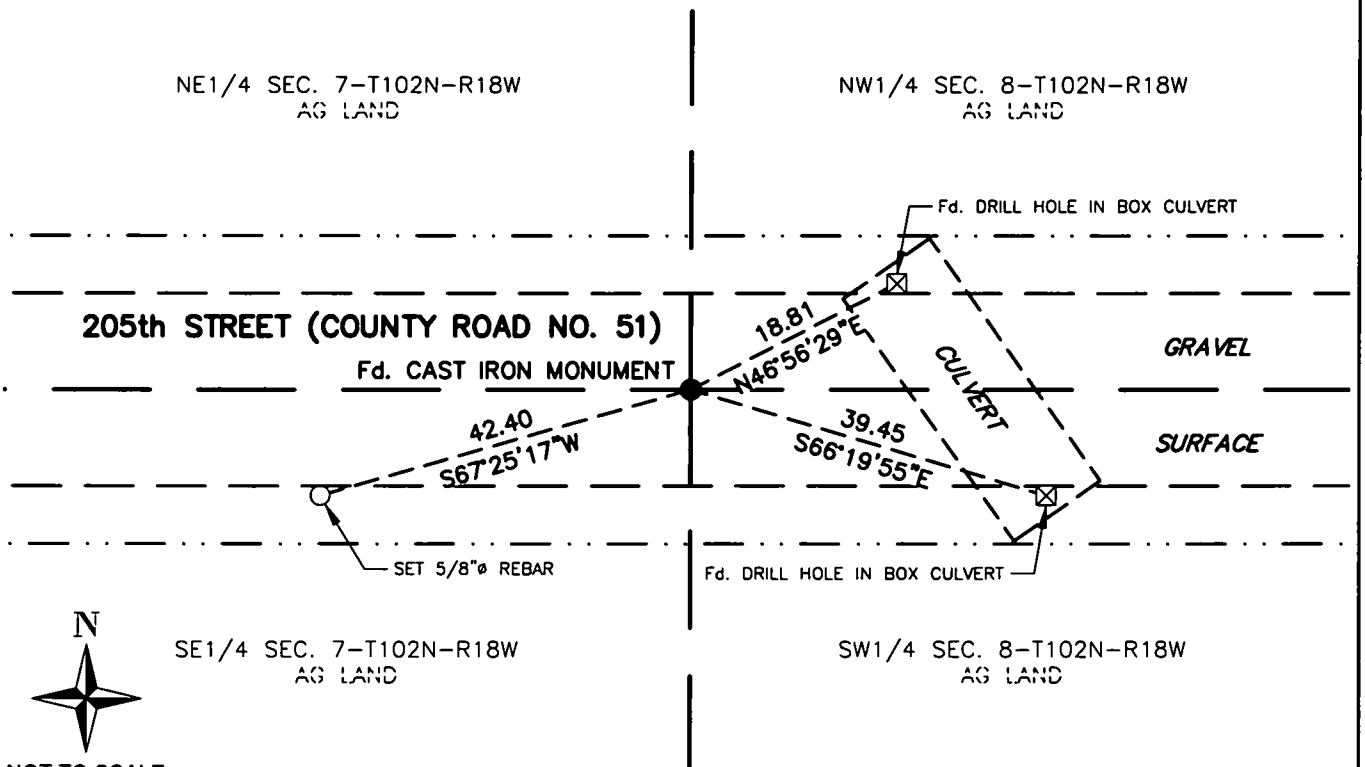
SKETCH OF REFERENCE TIES

At the corner location shown on the sketch

☐ On 2/26/2025 (DATE) found a CAST IRON MONUMENT

☒ left monument as found, ☐ lowered monument, ☐ removed monument (explain)

February 26, 2025: Jones, Haugh, & Smith crew recovered a cast iron monument. Checked existing ties and left cast iron monument in place and made ties.
