CERTIFICATE OF LOCATION OF GOVERNMENT CORNER

NORTHEAST Corner of Section 31, Township 103, Range 14W, 5 P.M.

STATE OF MINNESOTA, County of MOWER

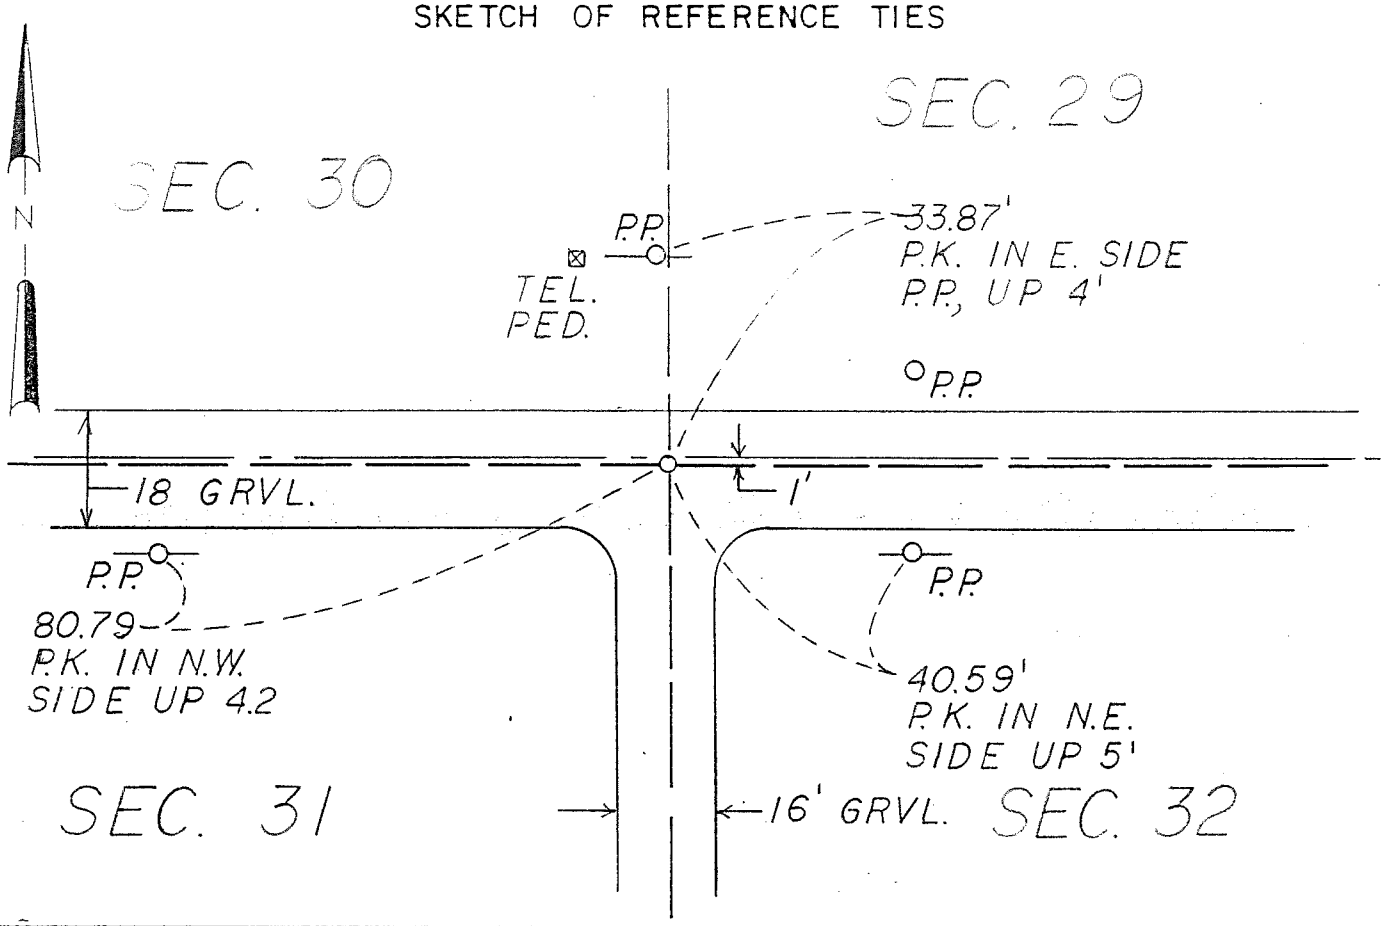
SKETCH OF REFERENCE TIES

On 7-29-91 found A 1/2" REBAR IN CONC. MON. 2.8' FEET BELOW THE SURFACE.

July 29, 1991 — Zenk Read Trygstad & Associates, excavated with a backhoe a trench 5 feet East to 5 feet West by 2.5 foot North to 2.5 South of the road centerlines by 4.5 feet deep and found a concrete monument 2.8 feet below the surface, 1 foot south of the east-west centerline and on the centerline to the south. The monument was removed during excavation.

An analysis of the record data shows no indication of the origin of the concrete monument. The monument agrees with the intersection of the township roads and is similar to others set by the County during section corner maintenance work. The monument is therefore accepted as marking the location of the original Public Land Survey Corner.

On 7-29-91 placed A COUNTY CAP IN PLACE OF THE CONCRETE MONUMENT.
