CERTIFICATE OF LOCATION OF GOVERNMENT CORNER

NE Corner of Section 26, Township 103N Range 16W, 5th P.M.

STATE OF MINNESOTA, County of MOWER

NE Corner Section 26-T103N-R16W

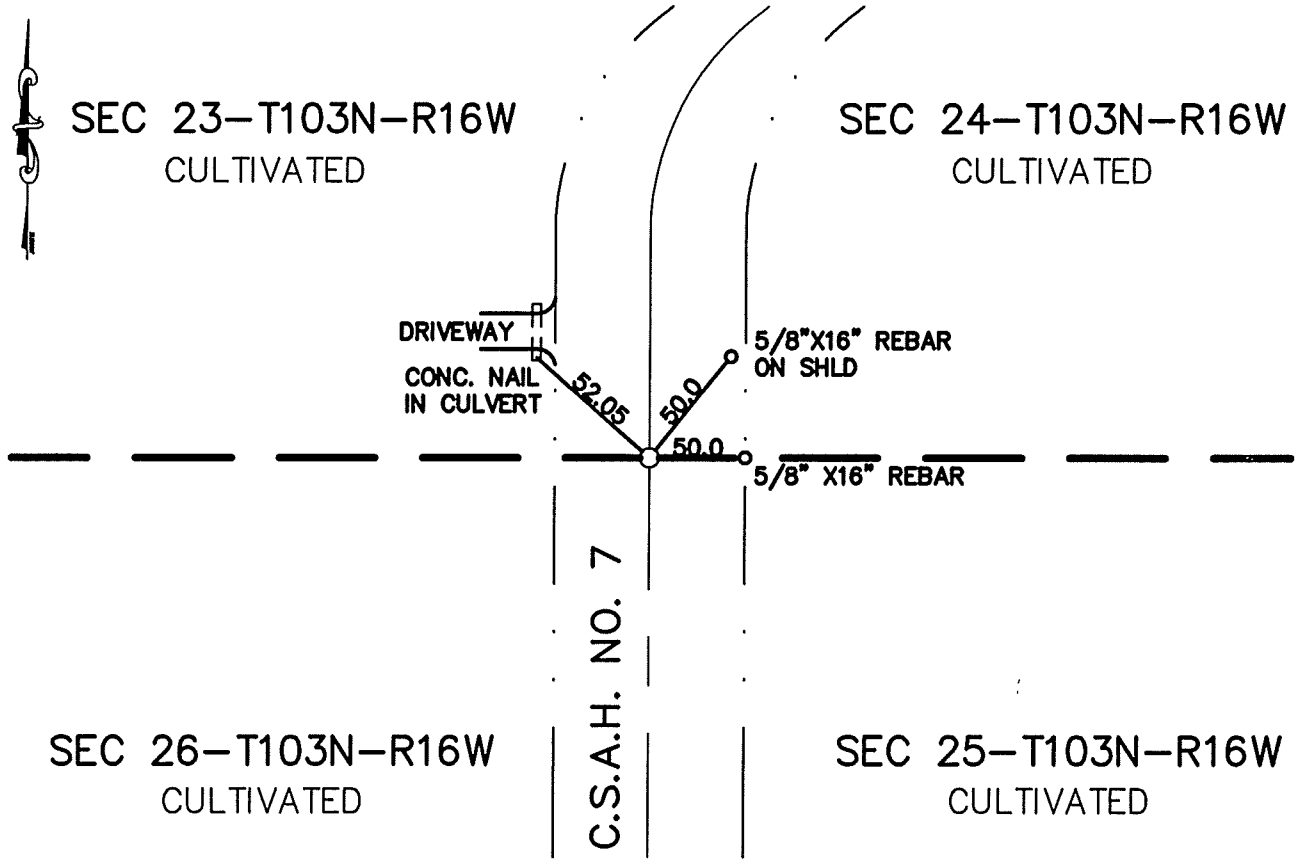
SKETCH OF REFERENCE TIES

At the corner location shown on the sketch

☐ On 05/05/2004 (DATE) found a CONCRETE MONUMENT WITH IRON PIN IN CENTER

2004 Jones Haugh and Smith crew, under direction of John Schulte, Mower County Surveyor RLS 13807, dug with county backhoe at a point computed from information on Interstate Highway No. 90 Right-of-Way Map. Uncovered a concrete monument with an iron pin in the center and wood hub on the south side of monument. Continued digging and found no further evidence of corner. Placed a 5/8"x16" rebar on the north side of monument found. Placed a 5/8"x16" rebar with cast iron monument above found concrete monument at road surface.

The monument is in agreement with the record and is accepted as best evidence of a perpetuation of the original public land survey corner.

☐ On 05/05/2004 (DATE) placed a 5/8"X16" REBAR WITH CAST IRON MONUMENT
