CERTIFICATE OF LOCATION OF GOVERNMENT CORNER

NORTHEAST Corner of Section 34, Township 104N, Range 18W, 5 P.M.

STATE OF MINNESOTA, County of MOWER

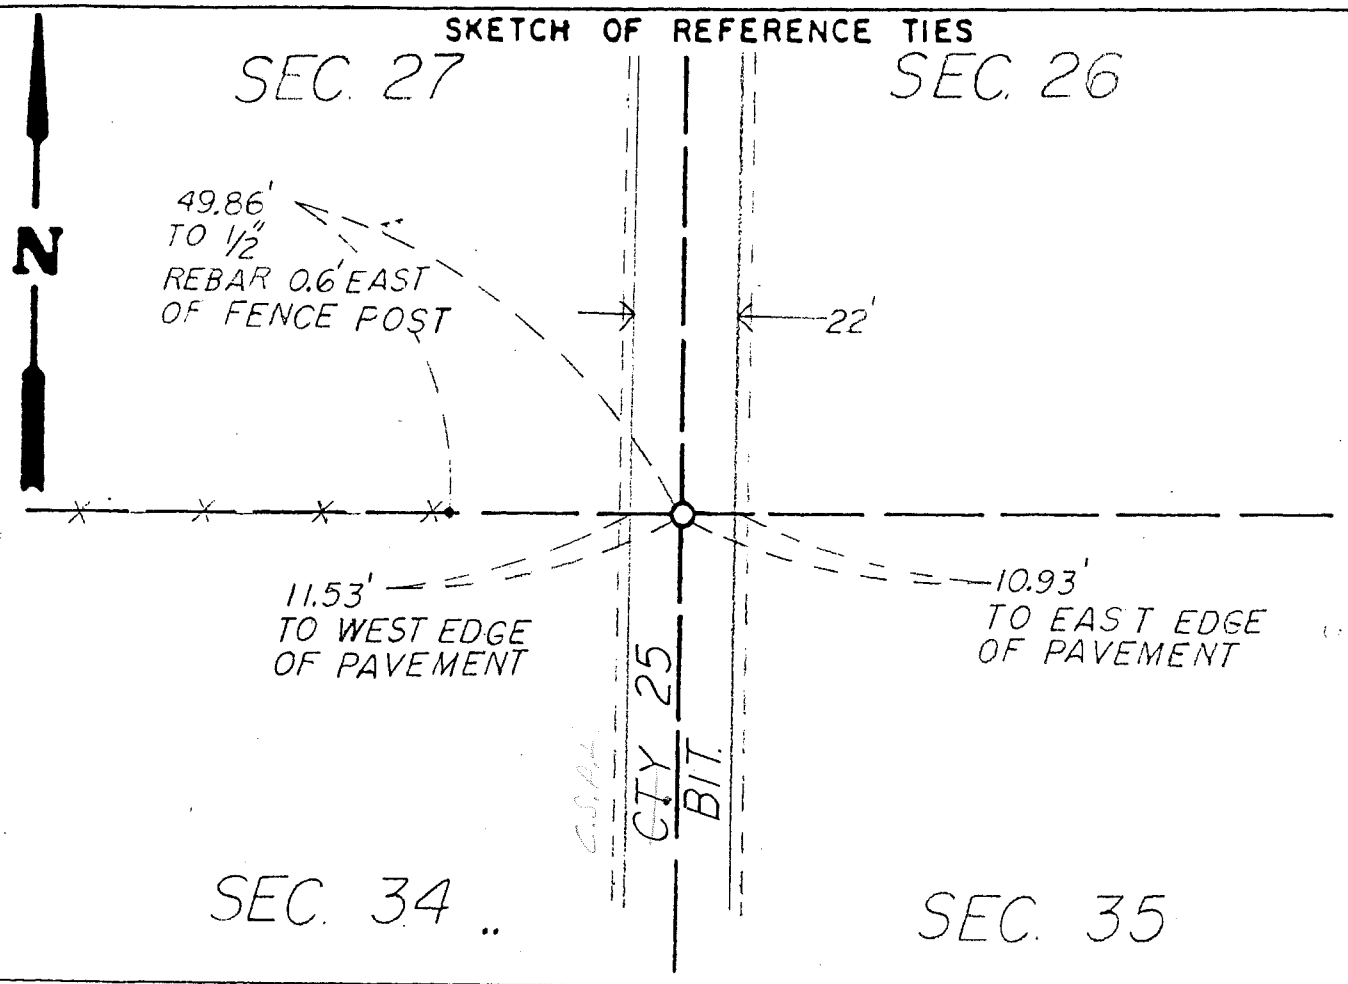
SKETCH OF REFERENCE TIES

On 7-10-90 found STONE AND BRICK

July 1990 — Zenk Read Trygstad & Associates excavated a trench 3.2 feet below the surface 4 feet West to 3 feet East of centerline and 2 feet South to 8 feet North of the Fenceline to the West. A stone 3.2 feet deep was found with pieces of brick on North side. A PK nail was found on the surface directly above the stone which agreed with the fence to the West and the existing centerline. A 1/2" pipe was set on the North side of the stone at the time of excavation.

An analysis of the record shows no evidence of the origin of the stone. The brick near the stone is evidence that the stone has been recognized and used as the corner and is accepted as marking the location of the original Public Land Survey Corner.

On 7-12-90 placed 5/8" REBAR AND COUNTY CAP OVER THE STONE
