CERTIFICATE OF LOCATION OF GOVERNMENT CORNER

NE Corner of Section 1, Township 103N Range 15W, 5TH P.M.

STATE OF MINNESOTA, County of MOWER

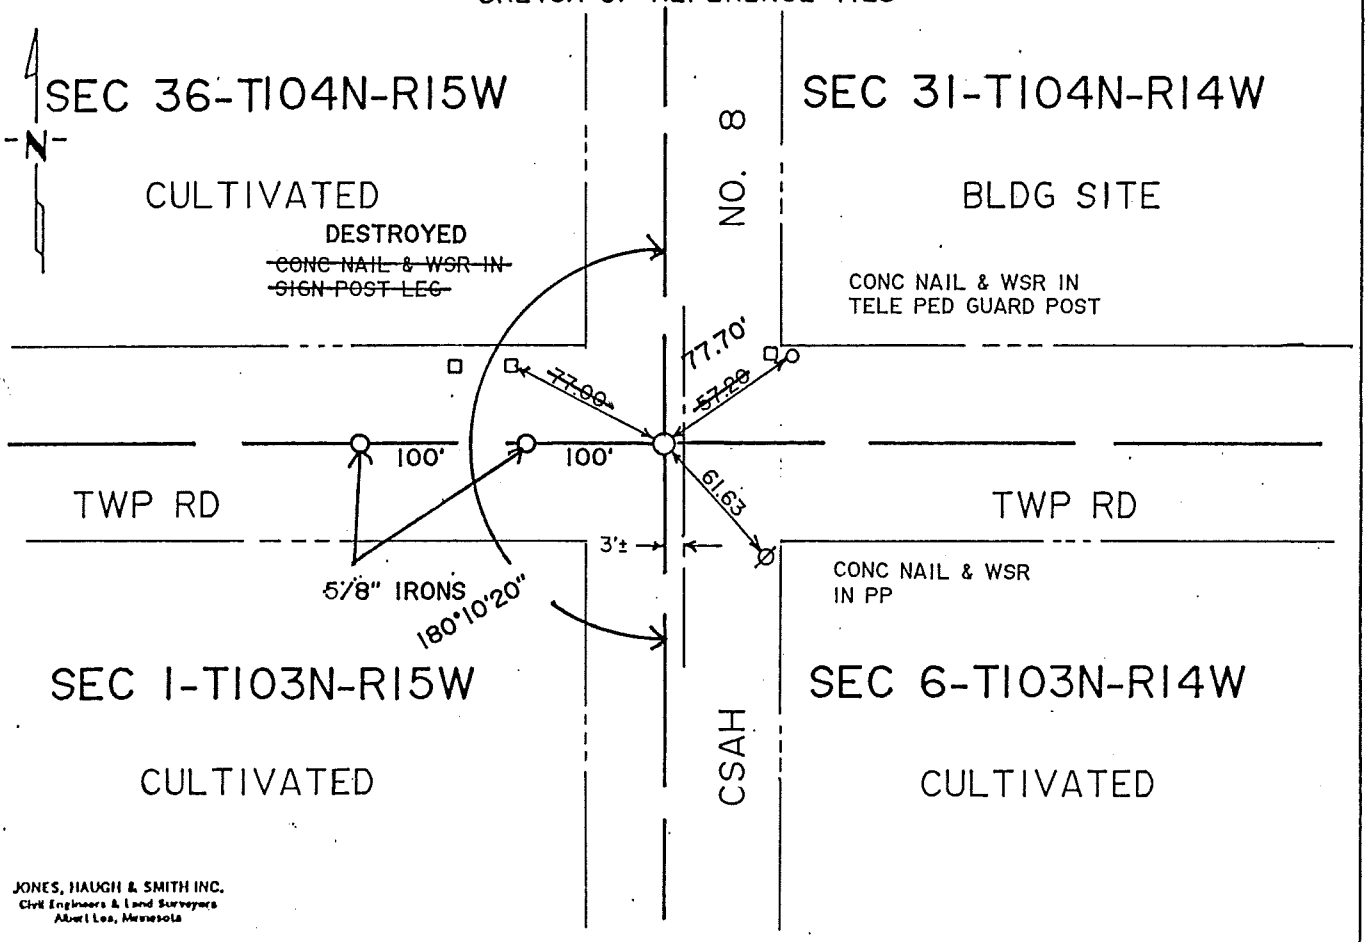
SKETCH OF REFERENCE TIES

☐ On 5-27-93 (DATE) found a 6"ø x 18" CONC MONUMENT WITH IRON IN CNT

1993 Jones, Haugh & Smith Inc crew under the direction of John H. Schulte IV, RLS 13807, dug a 4'x3'x6' hole on centerline of east-west township road and three feet west of centerline of County State Aid Highway No. 8. We found a 6" diameter x 18" concrete monument with an iron in center at a depth of one foot, which is in agreement with the records. Therefore we accepted the concrete monument found as the perpetuation of the original public land survey corner and set a cast iron monument near road surface above the monument found.

The monument found and cast iron monument set fits occupation lines within the section and is accepted as best evidence of a perpetuation of the original public land survey corner.

☐ On 5-27-93 (DATE) placed a CAST IRON MONUMENT
