CERTIFICATE OF LOCATION OF GOVERNMENT CORNER

S1/4 Corner of Section 26, Township 103N, Range 17W, 5th P.M.

STATE OF MINNESOTA, County of MOWER

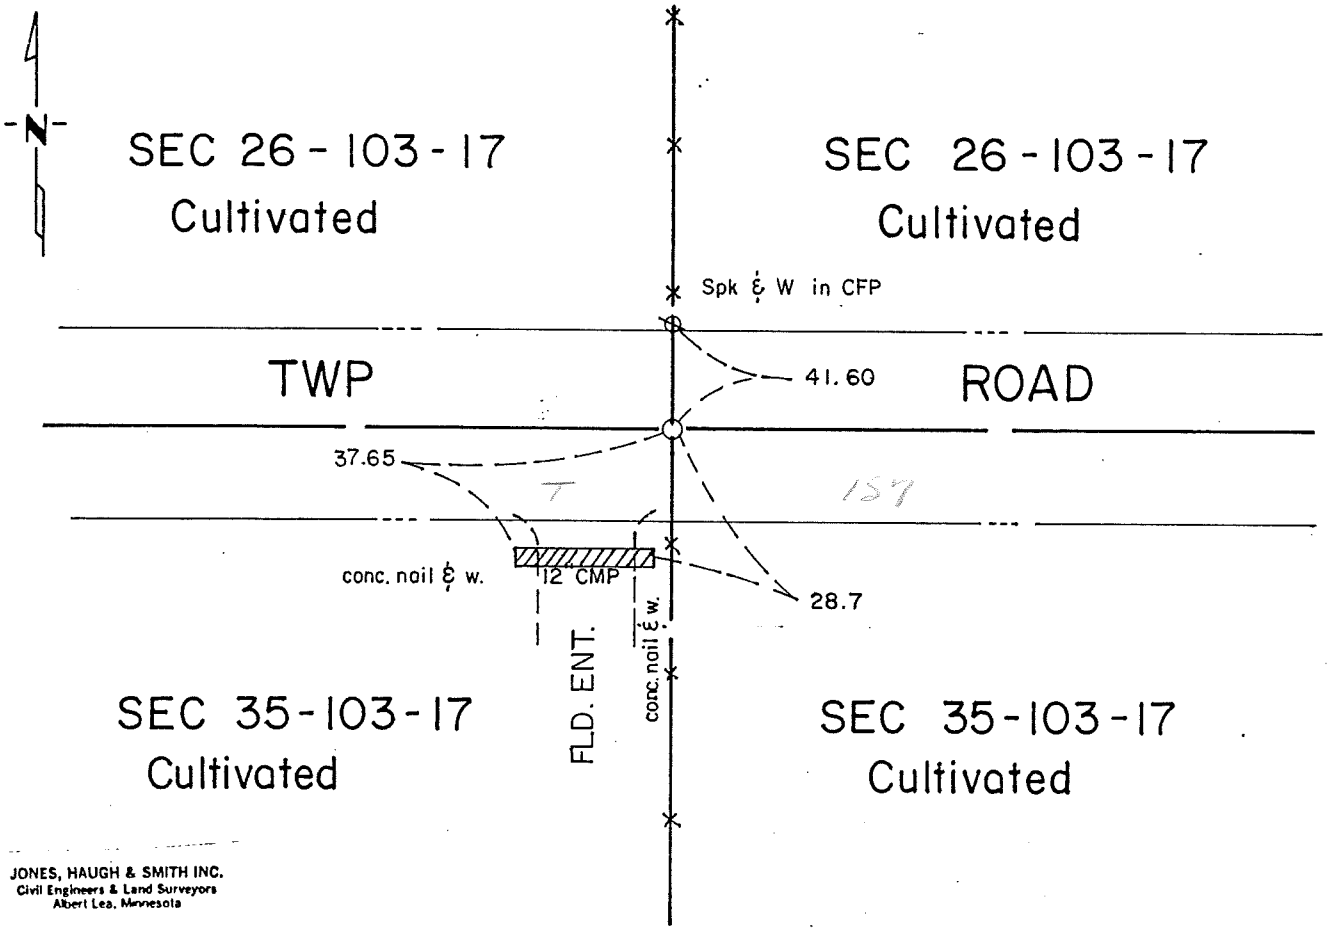
SKETCH OF REFERENCE TIES

☒ On 11-12-91 (DATE) found a 2" dia. x 30" long pipe 3.5' below road surface

1991 Jones, Haugh & Smith Inc crew under the direction of John Schulte, County Surveyor, dug with the County backhoe on the centerline of east-west roads in line with fence north-south and uncovered a 2" diameter x 30" long pipe 3.5 feet below road surface in virgin soil. Continued digging and found no further evidence of public land survey corner or a perpetuation thereof. Reset 2" diameter pipe as found and set cast iron monument over pipe on road surface.

The monument fits occupation and road centerlines within the section and is accepted as best evidence of a perpetuation of the original public land survey corner.

☒ On 11-12-91 (DATE) placed a cast iron monument over pipe
