SE COR SEC. 11 - T103N - R16W

SE COR SEC 11

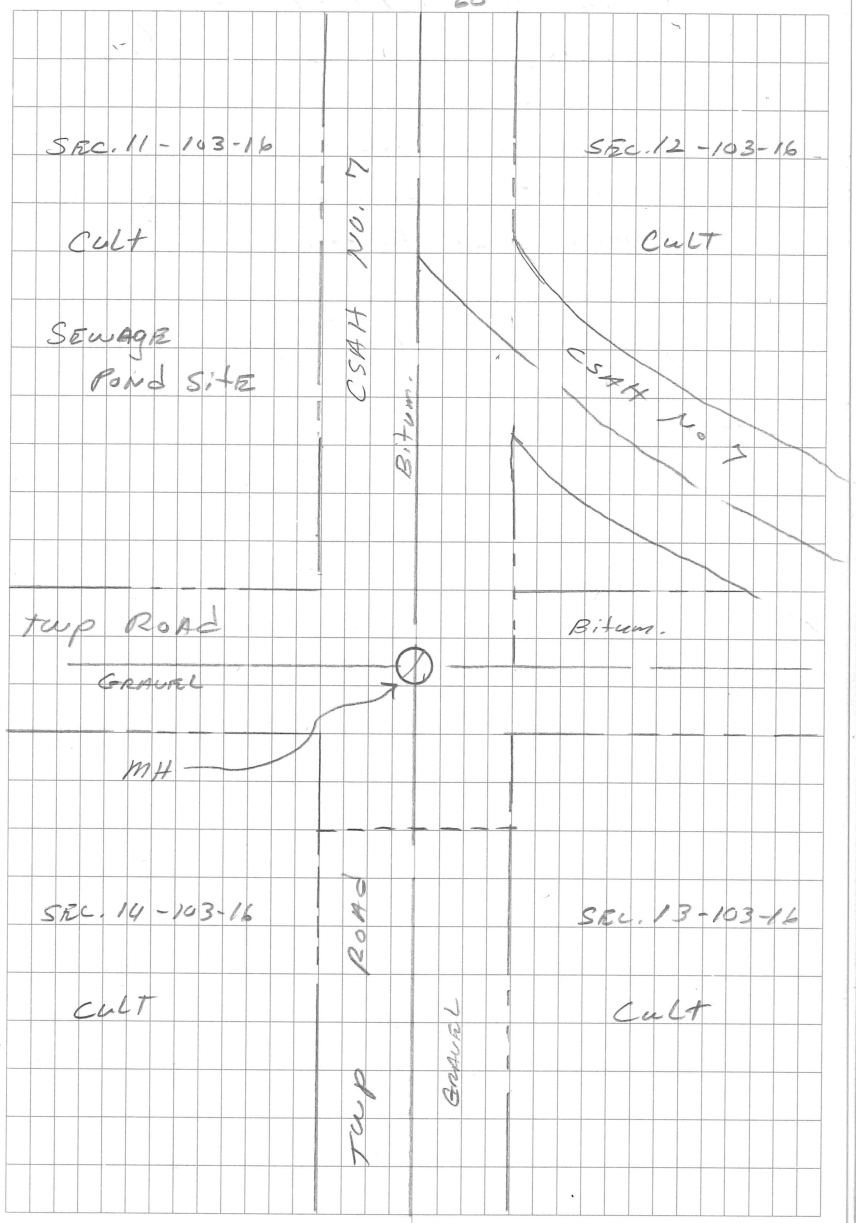
Mower county RECORD STATE CONC. MONUMENT IN PLACE.

Did not dig SECTION CORNER At this Point, MONUMENT APPEARS to HAVE BEEN DESTROYED WHEN MH WAS INSTALLED. MH is ON ℄℄ of ROAD North & South — AND ROAD EAST & WEST.

SET COR USING DATA FROM CSAH # 7 & CSAH #2 R/W PLANS. EXTENDED ℄ OF CO RD # 7 FROM WEST & INTER N-S ℄ OF 24 & SHOWN THIS COC FITS PLAN DIST FROM NORTH WHEN USING CORN. STA's ON PI & 1/4 SEC COR

NO MON SET, AS IT WOULD BE IN MH COVER.

2005 FOUND THAT MH COVER HAD BEEN RAISED & MOVED DURING RESURFACING & COUNT OF CSAH #7 USED DIST & ℄ FROM E1/4 COR & S1/4 COR SEC 11 AS SHOWN IN SKETCH TO COMPUTE COC OR COR
